Certificate of Crash Test according to

ISO 10542-1:2012 Wheelchair tiedown and occupant-restraint systems - SWM & ISO 7176-19 – 2008 Wheeled mobility devices for use as seats in motor vehicles

Test Report no: 0603208 Test object: Dietz Sango R Manufacturer: Dietz Power, Vlamovenweg 12, 5708 JV Helmond, The Netherlands

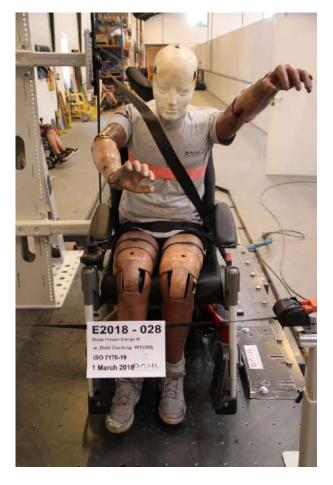
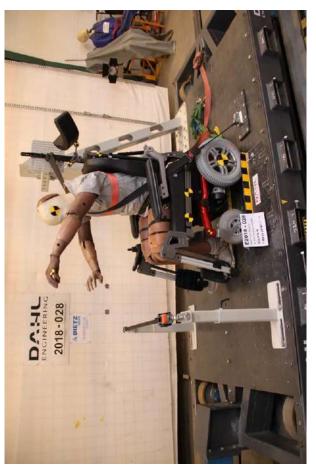
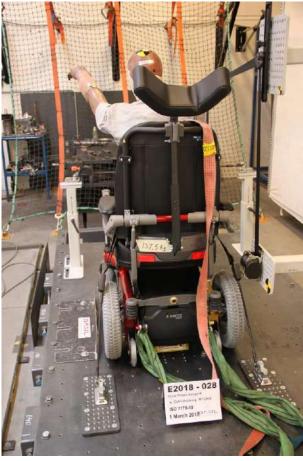
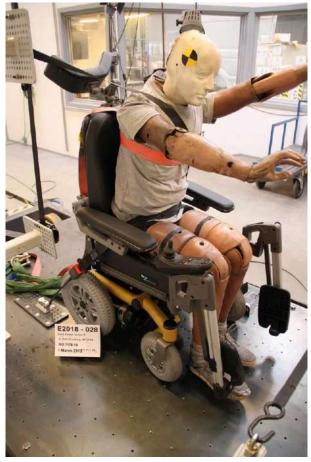
Post test photos

5.2.2	After the test	
	The wheelchair remained in an upright position on the platform	Х
	The ADT remained in the wheelchair with its torso at an angle of not more than 45° to the vertical, when viewed from any direction	Х
	There were no visible signs of material failure on the wheelchair securing points	X
	There were no components, fragments or accessories of the wheelchair with a mass of more than 100g that completely separated from the wheelchair	Х
	There were no fragmented or separated component, that may contact the occupant, produced with sharp edges less than radius 2 mm	Х
	There were no visible signs of failure on the wheelchairs primary load carrying components	Х
	There were no visible signs of failure on the wheelchairs seat adjusters	Х
	The ADT was removed from the wheelchair without the use of tools	Х
	The wheelchair was released from the tie-down system without the use of tools	Х
	The post test decrease of the mean H-point height is not more than 20%	Х
